DELAWARE RIVER BASIN

EVANS POND DAM

PHASE I INSPECTION REPORT NATIONAL DAM SAFETY PROGRAM

NJ 00394

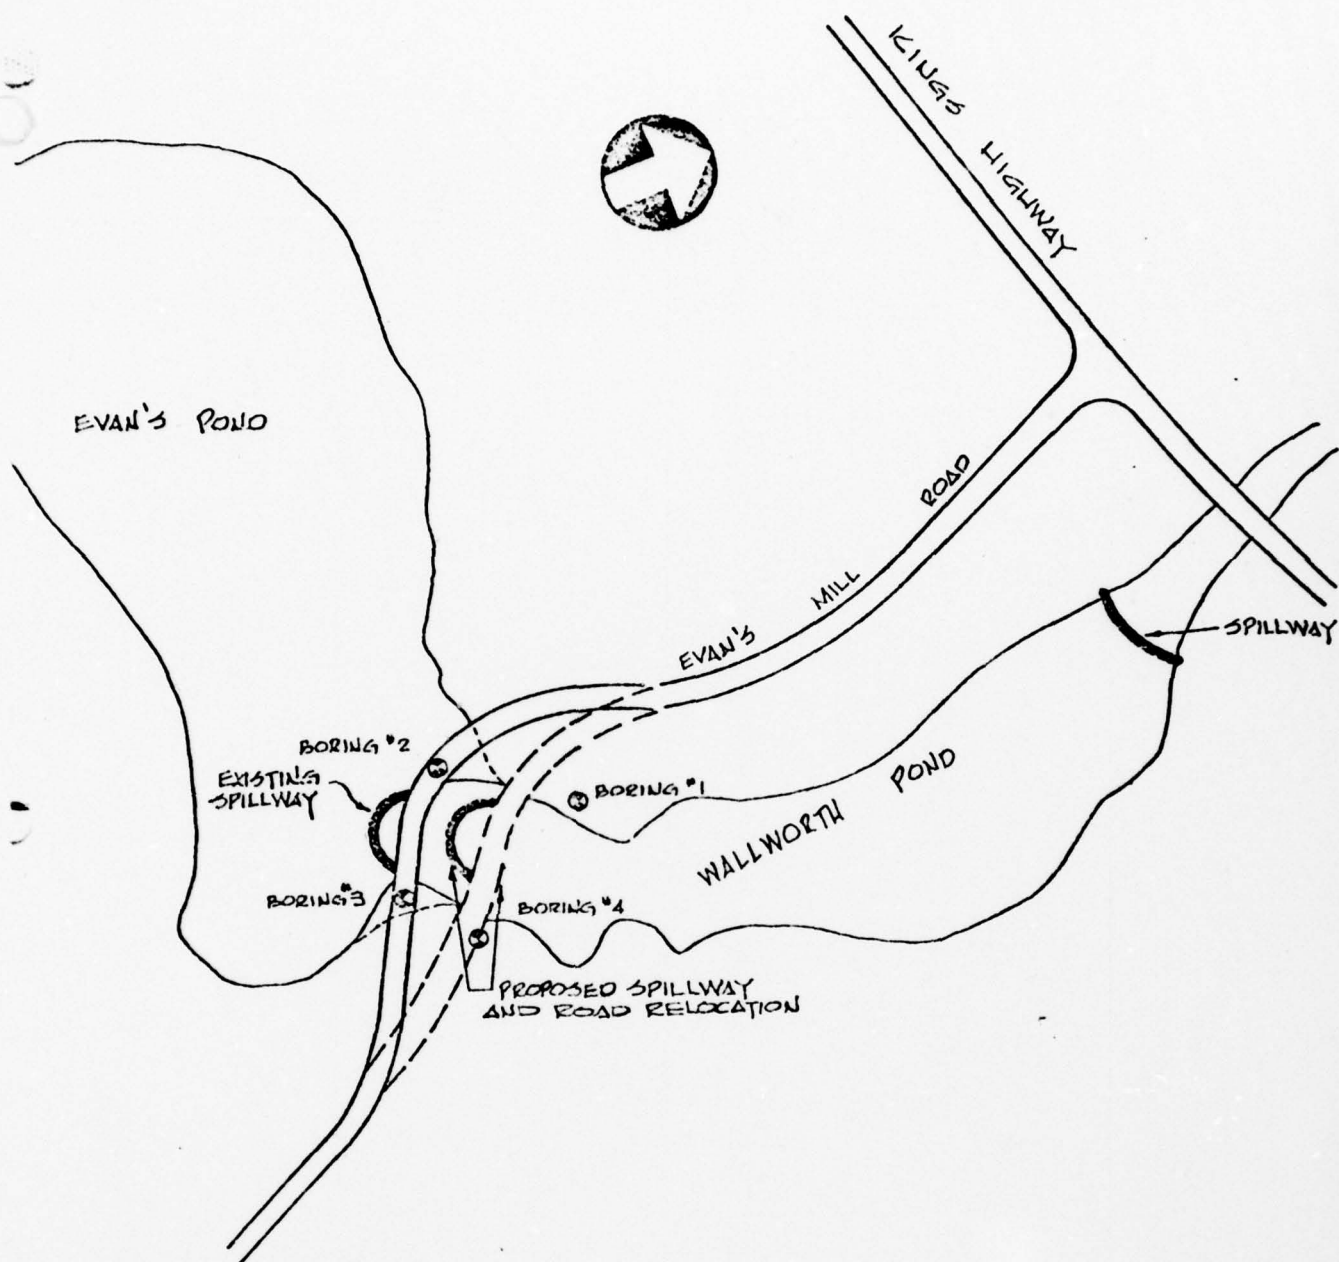
FIGURE 7

EVAN'S POND - DAM AND SPILLWAY
 PROPOSED SPILLWAY AND
 ROAD RELOCATION

AS SHOWN ON FIGURE 7, THE PROPOSED REPLACEMENT STRUCTURE AND ROADWAY WOULD

AN ALTERNATIVE TO REPLACING THE EVANS POND STRUCTURE WOULD CONSIST OF RAISING THE WALLWORTH DAM APPROXIMATELY TWO FEET AND REMOVING THE SPILLWAY AT EVANS POND. EVANS MILL ROAD WOULD STILL BE MORE THAN A FOOT ABOVE THE ELEVATION OF THE FIFTY YEAR FLOOD. EVANS POND WOULD HAVE A NORMAL WATER SURFACE APPROXIMATELY A FOOT LOWER THAN AT PRESENT. HYDROSTATIC PRESSURE AGAINST THE EMBANKMENT WOULD BE ELIMINATED FOR DAILY FLOWS AND GREATLY REDUCED FOR FLOOD FLOWS.
